OPERATING EXPERIENCE WEEKLY SUMMARY

Office of Nuclear and Facility Safety

June 4 - June 10, 1999

Summary 99-23

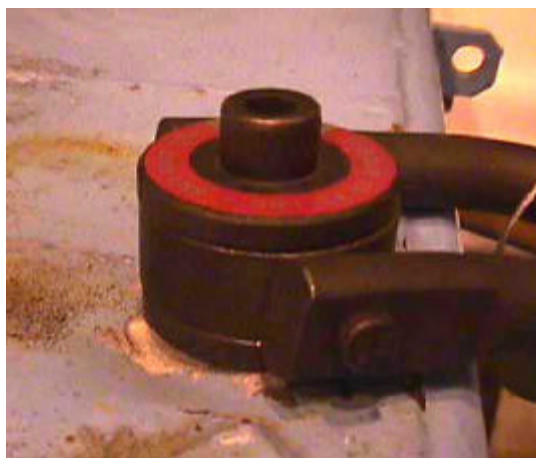
Figure 2-1. Swivel Eyebolt

On June 3, 1999, at the Idaho National Engineering Laboratory Test Area North, a lifting eyebolt separated from the lid of a shipping container as operators were attempting to remove the lid while it was still fastened to the container. They were using a 10-ton overhead crane and sling to remove what they thought was an 850-lb lid, when what they were really attempting to raise was the combined weight of the container, its contents, and the lid, or approximately 55,000 lb. The operators failed to completely disengage the lid from the container before attempting to remove it. Although all personnel were well clear of the area of the container when the eyebolt failed, this occurrence is significant because of its potential for personnel injury and equipment damage. In addition, the facility will incur the cost of process delays and damage assessments for the crane and the shipping container. (ORPS Report ID--LITC-TAN-1999-0006)

Engineers do not believe that the force applied during the occurrence exceeded the capacity of the crane or lifting components. However, operators have tagged the crane out of service until engineers complete a material analysis and inspection. Engineers will also evaluate damage to the ISO container before it is used in facility operations.

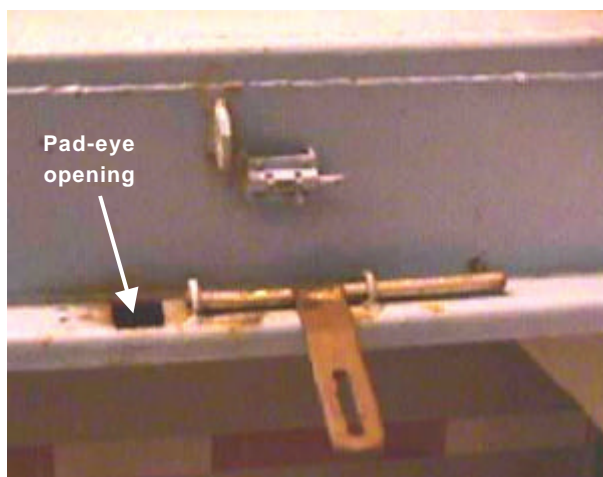
Figure 2-2. Latch Assembly

Containers of this type, which are commonly referred to as "ISO" containers, are air-sea-land shipping containers manufactured to International Organization for Standardization specifications. ISO containers are designed to protect and contain their contents in case of fire or accidents. The container used at the Test Area North is loaded and unloaded from the top. Four swivel eyebolts (Figure 2-1), attached to the flat lid with washers and nuts, allow for handling the lid. The lid is held in place with eight latch assemblies (Figure 2-2).
